Bi - Annual Surface Water Monitoring Report

June 2021 to December 2021

Project: Sydney Metro City & Southwest – TSE Works

Document No: SMCSWTSE-JCG-TPW-EM-RPT-097504

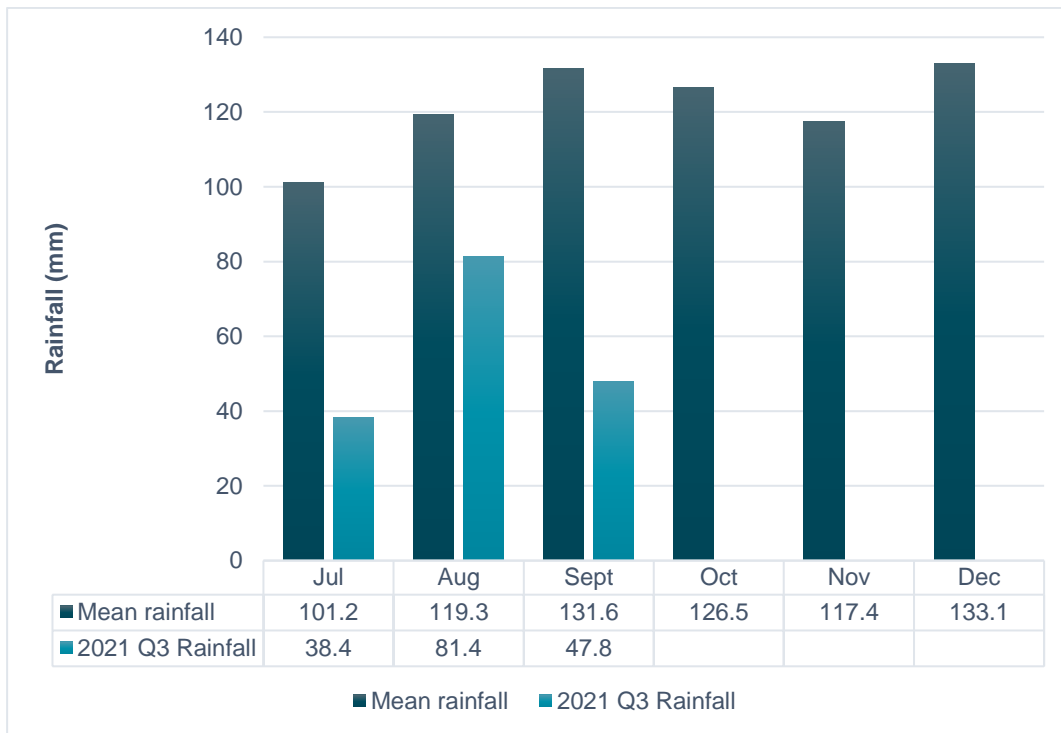
Figure 1 Monthly mean rainfall compared to 2021 monthly total rainfall

Weather data (including rainfall) is collected using data from the Sydney Observatory Hill weather station, accessed via the Bureau of Meteorology website (<http://www.bom.gov.au>). Figure 2 depicts the total monthly rainfall for the monitoring period against the long-term average for the same months.

During this reporting period, lower than average rainfall was recorded in July (38.4mm), August (81.4mm) and September (47.8mm) compared with the historic average. The lowest rainfall volume was recorded in July where only 38.4mm of rain was recorded compared to a historic mean of 101.2mm. Sampling events were undertaken in September (Q3).

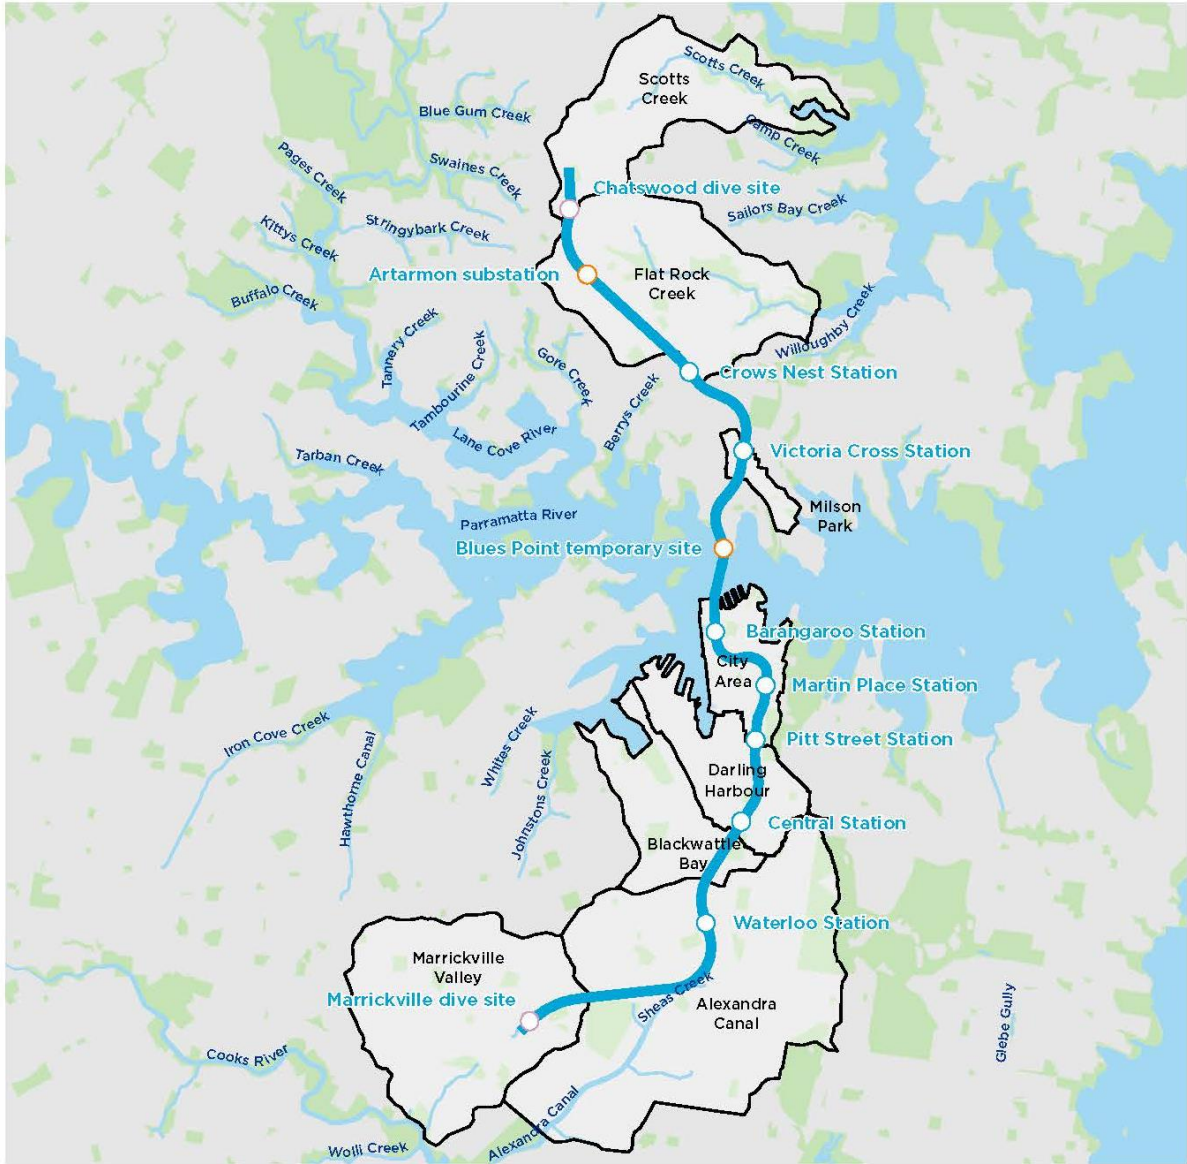
Figure 3: Surface water catchments and watercourses (Source: Figure 21-1 of the Sydney Metro City & Southwest EIS)

The project is located within the Sydney Harbour/Parramatta River catchment and the Cooks River catchment. Within these two catchments there are five local watercourses that are located along the tunnel and station excavation (TSE) works alignment, which drain into Middle Harbour, Sydney Harbour or Botany Bay (Figure 3).
